**Architectural and Archaeological Impact Assessment for the property
known as The Secret Garden, on the Remainder of portion 1 of the Farm
Cluny Park no 14809, Msunduzi Municipality**

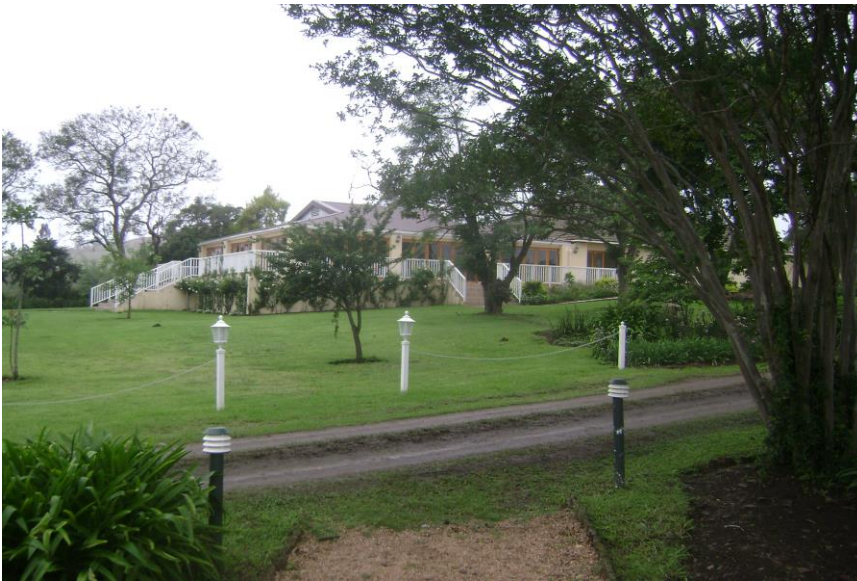
The main house has little merit except that it is an old structure. Accretions have taken place over the years, such as tiling and altered skirtings, and there is little left which shows the original character of what was more than likely a very simple and utilitarian structure.

Fig: the main house from the north

Although the main house is over 60 years old, there is little architectural, social, technical, or historical merit. However, the structure is over 60 years old, and any applications for its alteration or demolition in the future should be made through the correct processes. It is

recommended that the alterations stand as is, and that the Heritage legislation be applied and enforced with any further work.

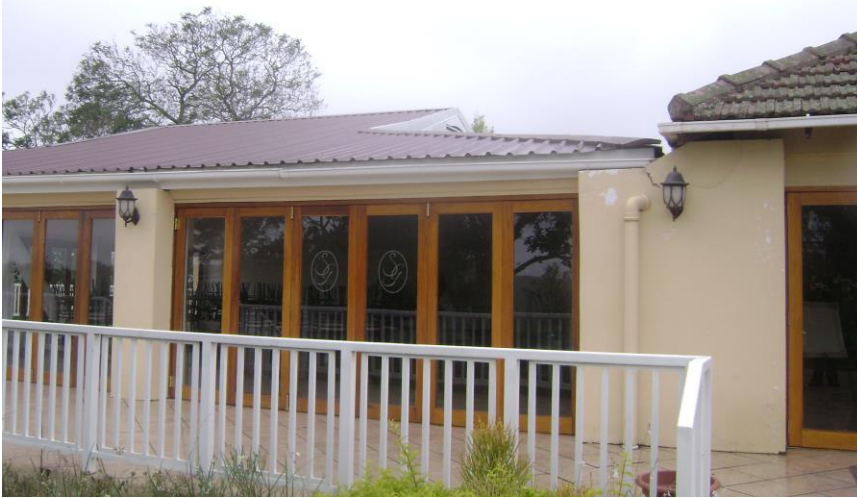
The alterations which have been carried out both internally (minor) which involve the removal of sanitary ware and the construction of bathrooms, and externally (major) which include the addition of a large room to the east of the house and a small extension to the rear which has become storage space, are simple, of like material and new windows are of varnished meranti rather than painted timber. Separation between the structures is achieved with a wide valley gutter, which also assists in the reading of the different pitches.

Fig: Showing the junction of the two buildings

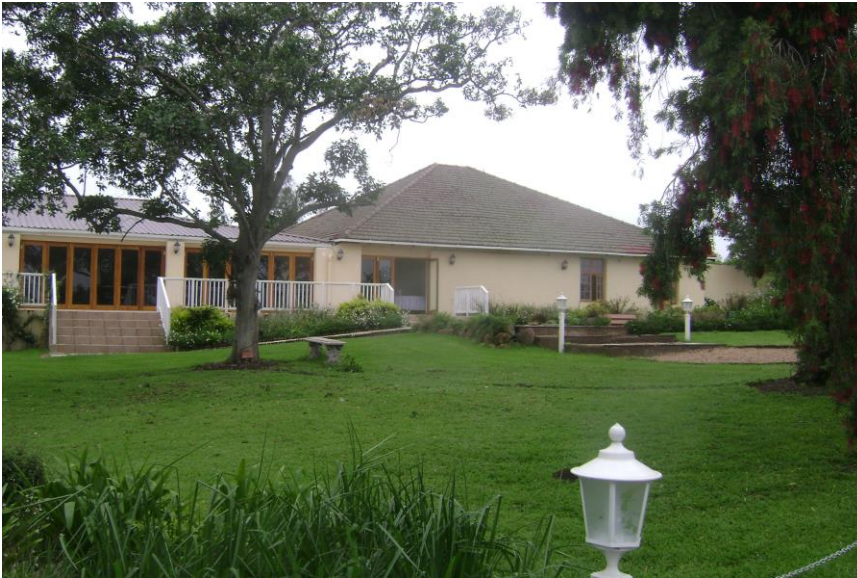
Fig: Showing the relative scales of the old building (to the rear) and the new building (to the front)

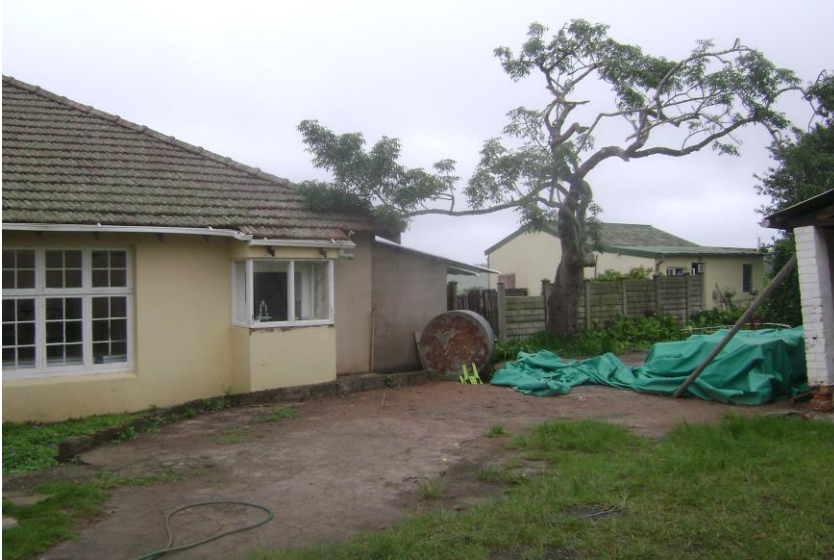
Fig: rear showing added rear 'afdak' with plastered wall

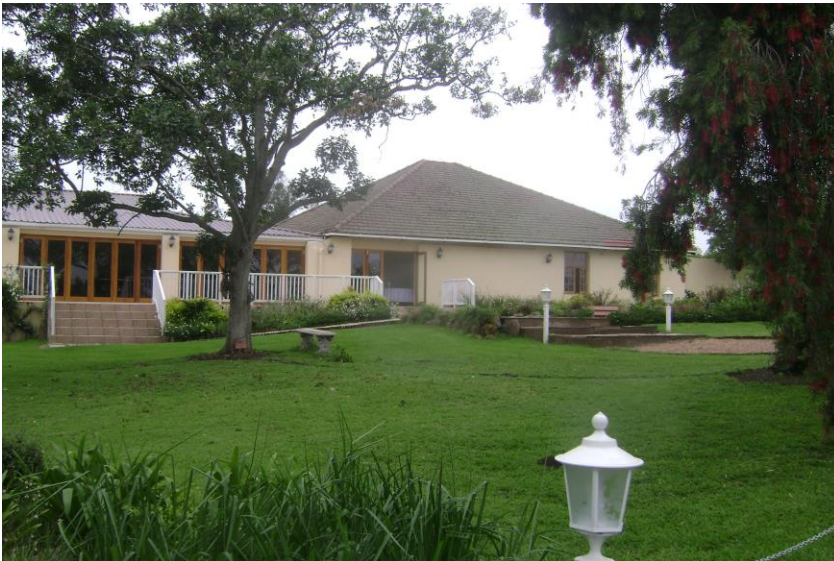
Fig: showing main house and addition to the left

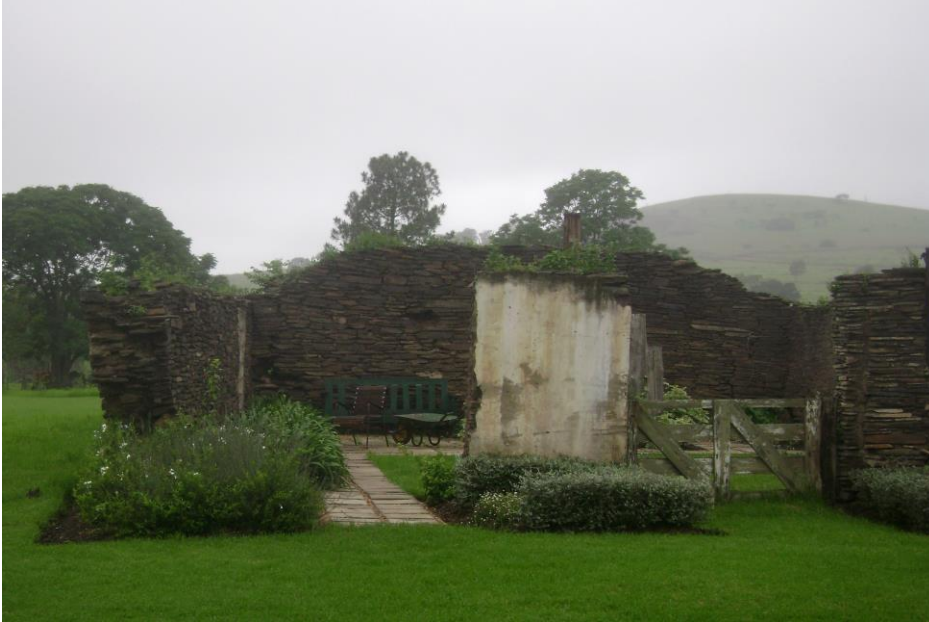
Fig: Showing 'ruin' as the wedding photograph backdrop

The structure has been stabilized and forms a coherent part of the pastoral landscape, with the backdrop of the building next to it which is being reformed as a chapel. The ruin continues to have life even though it no longer functions as a formal building. It is of picturesque rather than architectural value.

That the ruin has been interpreted by the owners of the property in an appropriate manner in that it continues to have life. The treatment of the ruin should be acceptable in its current state.

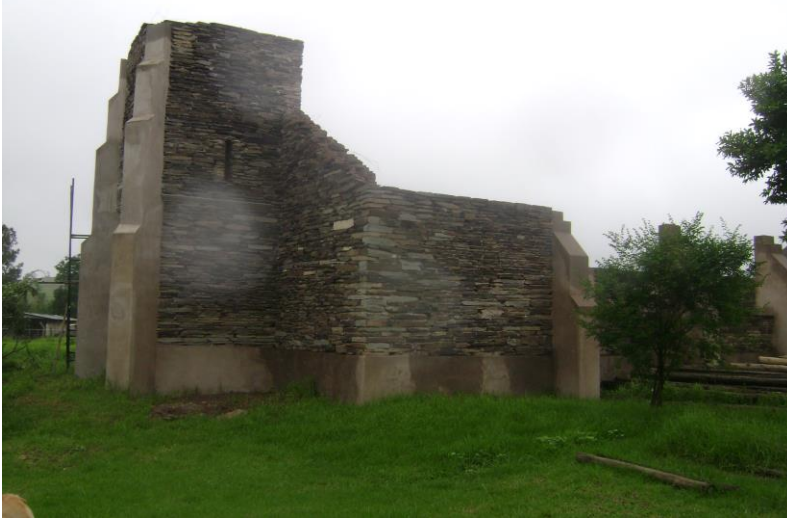
Fig: showing Chapel in process of construction from north

As the chapel is essentially a new build out of found material from the site, it is difficult to classify in terms of what it replaced. Certainly the author has to take the statement of the owner at face value in this regard, and assume that the shale structure which it is replacing was in fact dilapidated and uninhabitable, as many of the older buildings on the site were, being serviceable and utilitarian in nature. Giving what can be problematic materials to recycle a new lease on life and preserving a certain pastoral topophilia must be noted. The final scale of the building is indicated by the height of the gable ends and does not appear at this stage to be overwhelming. The intention of the owner is to roof with corrugated sheeting rather than IBR.

The treatment of the construction of the new chapel is historicist but within a themed context. It is not inappropriate in terms of scale nor material, and, in the absence of the knowledge of the nature of the prior structure, should be acceptable as it stands.

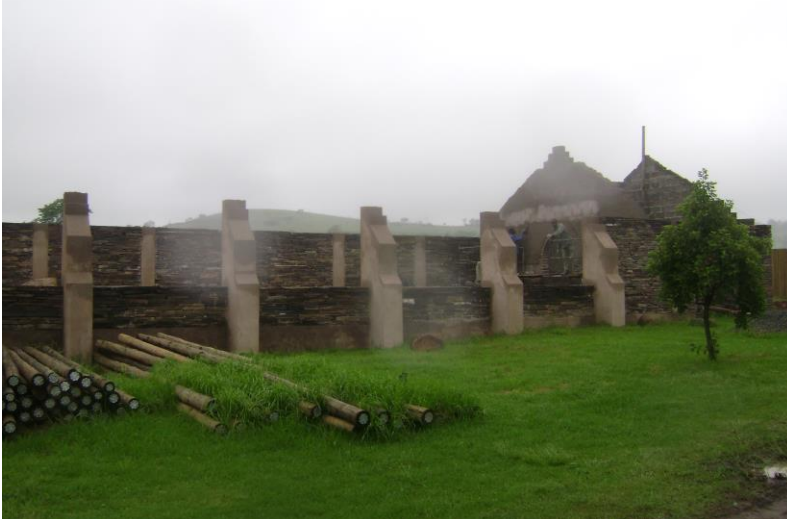
Fig; Chapel under construction

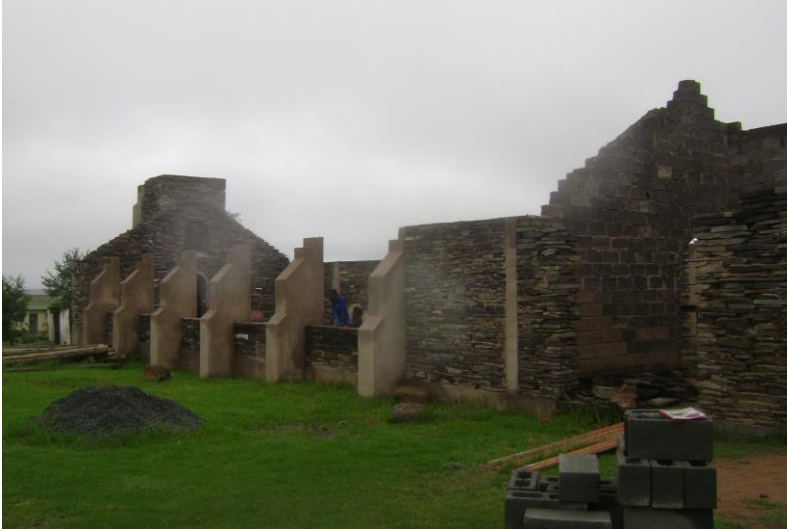
Fig: chapel from south west

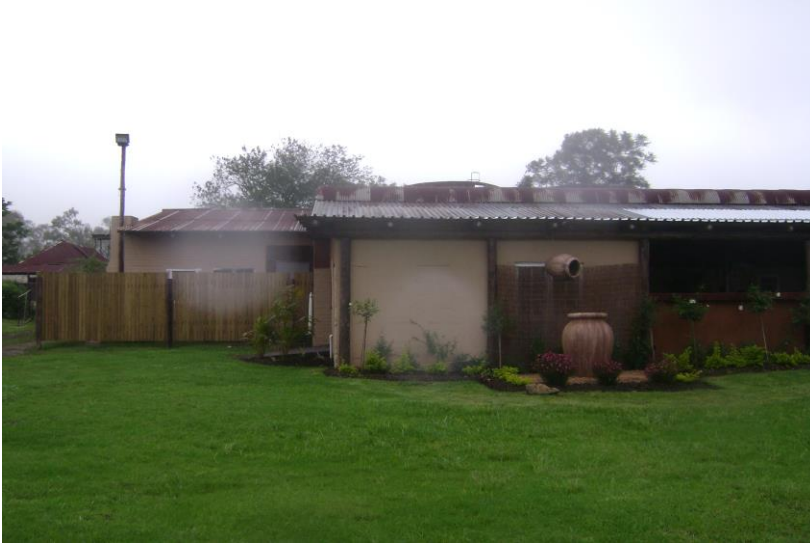
This is an agricultural structure which once housed stock, and is flanked to the west by two silos. The large roof structure functioned as a dairy for many years but is currently used for the storage of implements, building supplies and tools. It is an incremental utilitarian building, of mixed construction under corrugated sheeting. Part of it is currently used for staff accommodation and storage.

Fig: Old dairy/ outbuilding 1 showing enclosed area housing staff with the sheds behind.

Summary: A general premise with respect to Outbuilding no 1 should be adopted. Because of its incremental construction, there are portions which are over the age of 60 years, and it is strongly suggested that Amafa be contacted in the event of any alteration, demolition or addition to this structure. It reads as an utilitarian agricultural structure and it is the author's understanding that this is the aesthetic ethos that the owner wants to retain. Major alterations will thus alter the feeling of the building totally.

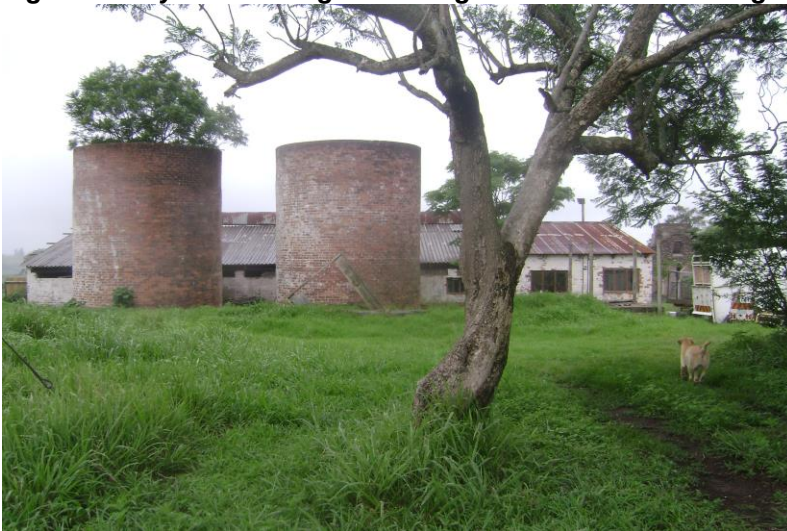
Fig: Outbuilding 1 from the south side of the site showing brick silos

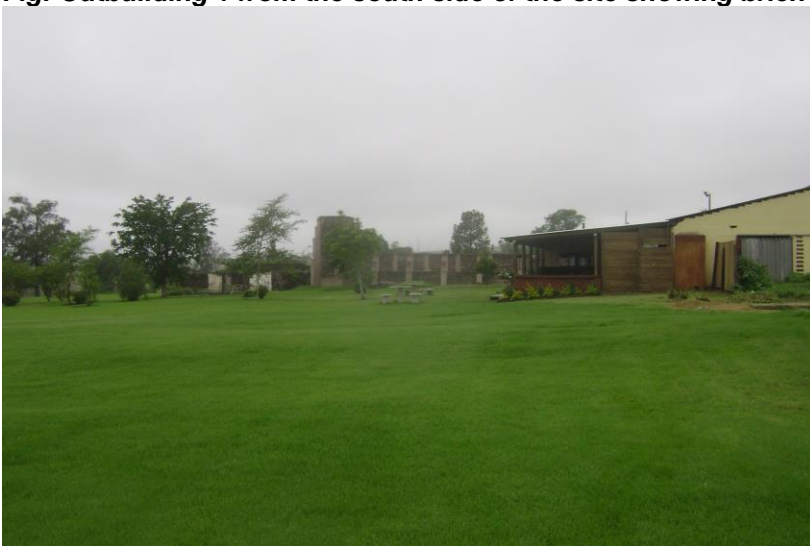
Fig: view across site showing ruin (left) chapel (centre) and outbuilding 1 (right)

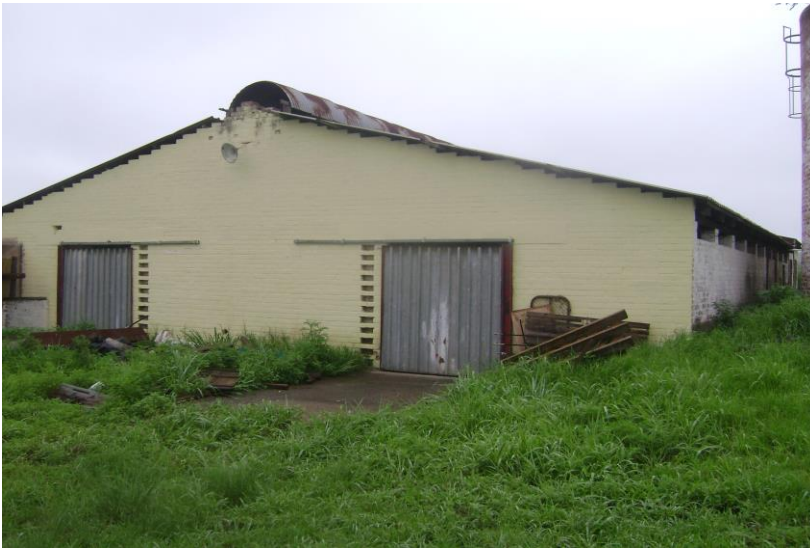
Fig: view from north west showing entrance doors to the old dairy shed

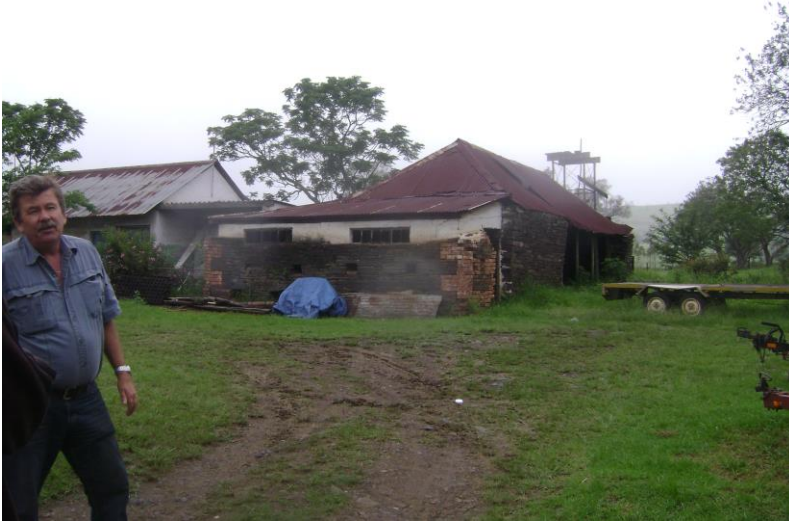
This consists of a series of buildings informally linked together. The most notable is the corner building which is a simple veranda building of shale construction under a corrugated sheeting roof. (in fig below this is situated in the centre) This is currently unused and according to the owner 'It took a hammering with the November storms, we will just have to see if it gets closer to collapse.' Adjoining it (to the left in the fig below), is a reasonably nondescript but of-age plastered and painted building under corrugated sheeting which is also currently used as staff accommodation.

Fig: Showing outbuilding 2 with old shale building in the centre.

Summary: The connected structures that comprise Outbuilding 2 display good examples of settler vernacular. Given the possible connection with the shale structure and the McIntosh settlement, it is strongly recommended that Amafa be involved in any plans to repair, alter, add to or demolish these structures.

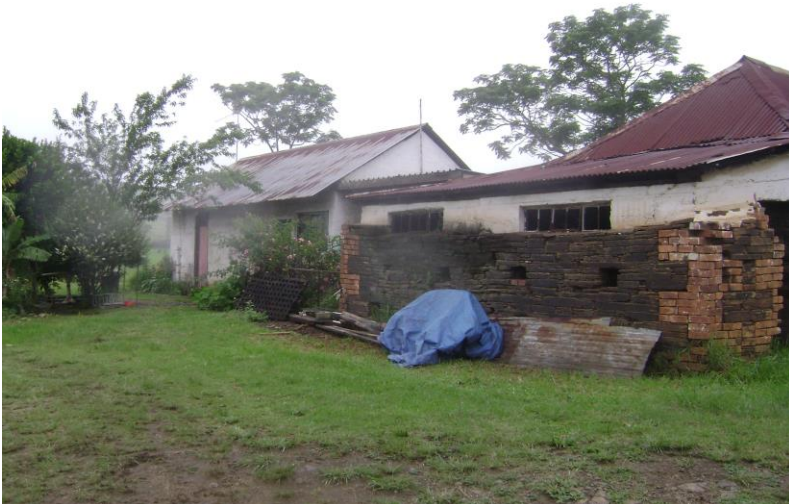
Fig: showing outbuilding 2 showing mixed shale and brick wall

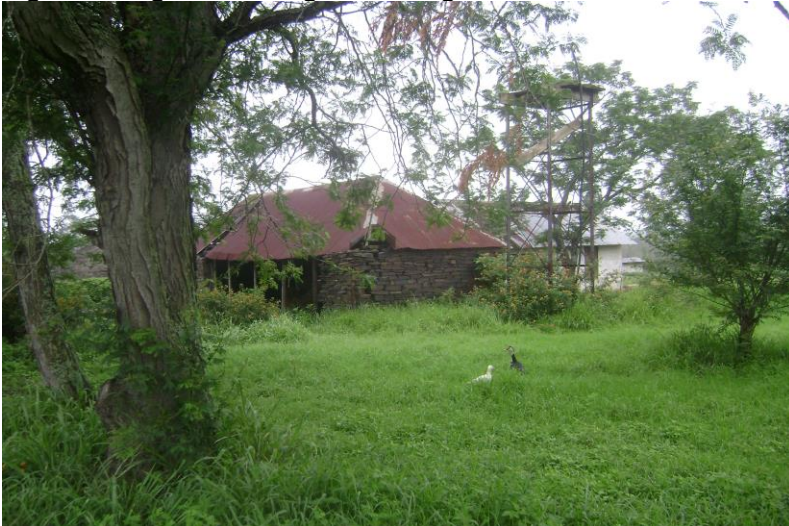
Fig: outbuilding no 2 shale veranda building

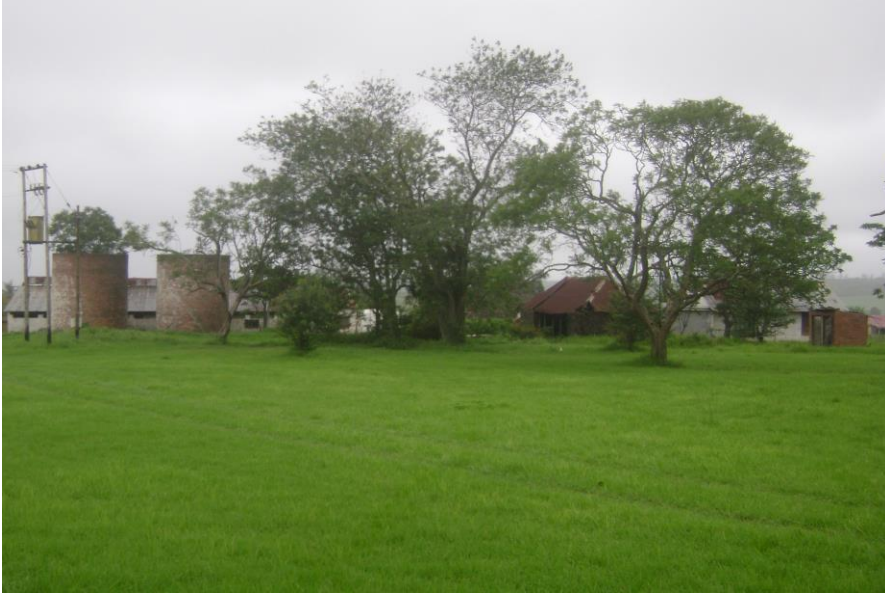
Fig: Showing outbuilding no 1 with the silos in relation to outbuilding no 2 to the right

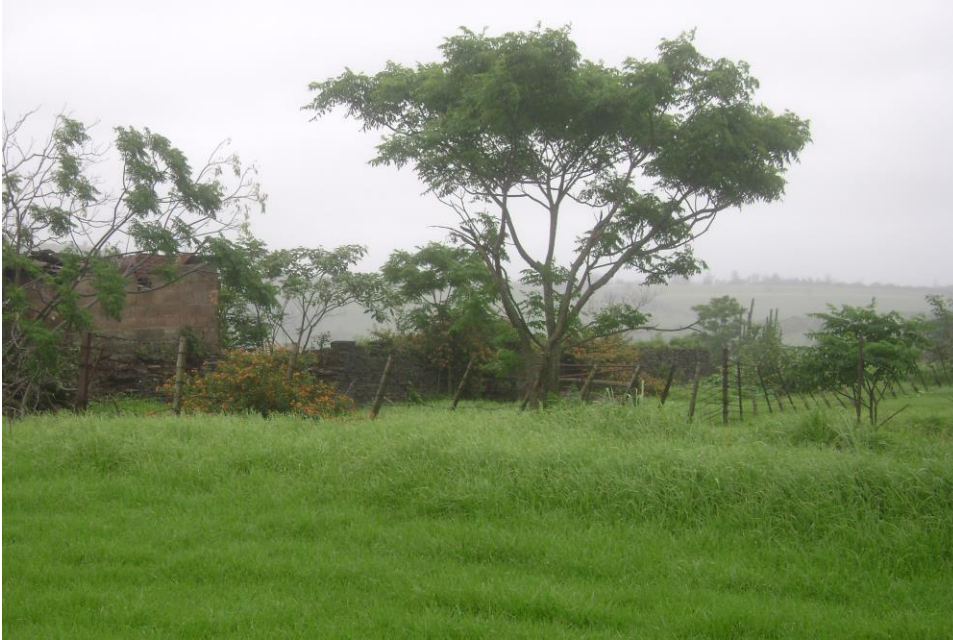
This consists of a concrete block building with a corrugated sheeting roof, in a state of disrepair. It has no aesthetic value, and is not of any architectural, historical, technical, scientific nor social value. However, more importantly is the series of shale walls which run in its proximity, and recourse should be made to Amafa for any addition, alteration or demolition of these structures.

Fig: Showing outbuilding no 4 to the left of the copse

Summary; the structure comprising Outbuilding no 4 is of little value. However, the wall around it are of interest from an historical and technical point of view, and their management should include support and direction from Amafa.

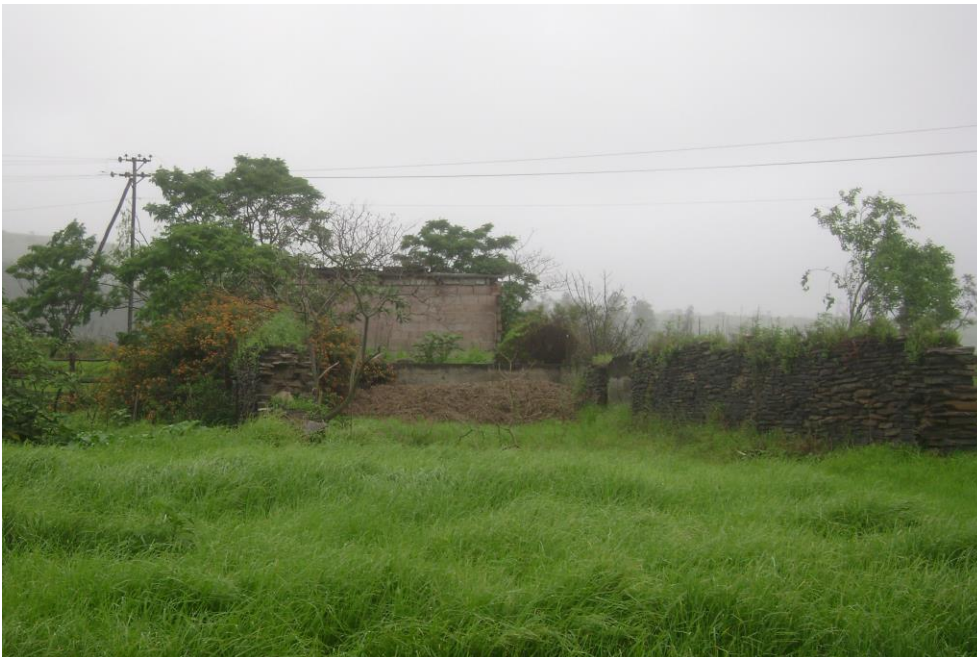
Fig: Showing outbuilding no 4 with some of the old walling

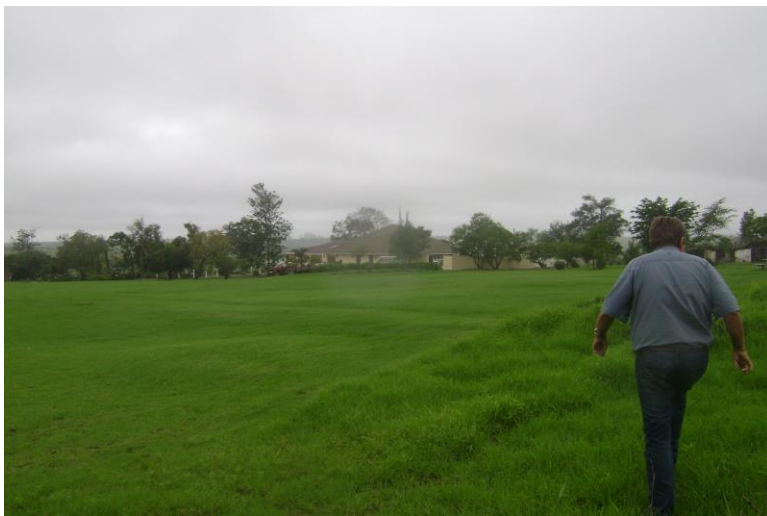
Fig: main house in distance from area intended to build staff houses- once planning and excavation has begun, it is strongly recommended that a qualified archaeologist be consulted and be readily available with reference to any excavated material, archaeological, industrial or historical, which emerges.

I do not believe that any additional archaeological mitigation is necessary at this stage. I recommend, however, that archaeological assessment should precede any additional developments beyond the existing structures and the current car park. Further, any construction and development activities resulting in the discovery of archaeological material must be suspended immediately, pending evaluation by a competent archaeologist.
